Conservation Plan and Architectural Documentation of Jani Khan's Tomb

Abstract: This research exploration addresses the documentation and analysis of the architectural features of Jani Khan's Tomb, an 18th-century Mughal tomb in Lahore, Pakistan. Since its construction, the tomb has been greatly vandalized owing to the adverse weather factors and nonprofessional workmanship in restoration. It is primarily intended to establish a flowchart of conservation initiatives using ICOMOS conservation charters like the Burra Charter and the Venice Charter. Assessment of the tomb involves assessed architectural analysis and material decay systematic analysis through history and archaeology. The plan includes comprehensive documentation of the tombs architecture, decoration and use of material proper to restoring methods for restoration such as lime mortar and fresco methods. A critical aspect is public participation to be sensitized and able to share insights to the future generation on the significance of the tomb. Being a historical approach, the research aimed at enhancing historical orientation and participation in the long term conservation initiatives. The existing research endeavor wi

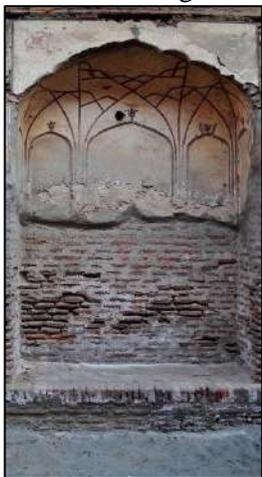
Figure 04 Qalibqari

Figure 04 above shows that the qalibqari on the inner side of the cusped arches and the inner surface has seen a loss of color and pigmentation. Furthermore, the upper surface of the region is severely compromised and requires restoration. The masonry is damaged, and the frescoes in the triangular parts above the cusped arches have deteriorated and are entirely faded. It is evident that the bricks are absent and the plaster layer has significantly deteriorated. The missing bricks are due to damage inflicted by avian and insect activity. Furthermore, the little masonry and stonework is not only absent but also damaged in several areas.

The damages have obliterated all demarcations and borders of the architectural features employed in the tomb. This image illustrates that each arch and region has distinct damages, in contrast to Figure 4. The masonry is damaged, making it hard to distinguish the individual components. The multi-cusped arches are damaged, with shattered edges that have resulted in a loss of normal alignment and aesthetic appeal. The lowest section has completely lost its brickwork, perhaps resulting in a compromised foundation at the surface level. Furthermore, insects may infest the lower region, potentially causing additional damage to the foundation; repairs should be conducted to prevent future deterioration. The white powdery spots indicate significant damage to the structure resulting from water collection and absorption into its surface. This leads to moisture dissemination throughout the entire structure and its surfaces, which may subsequently diminish the building's durability and compromise the foundation's integrity.

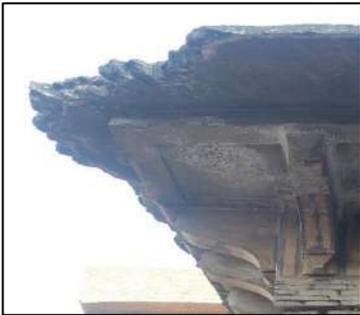
Figure 05 Façade treatment

The borders of the building's front facade are compromised, suggesting that the eaves have sustained damage from precipitation and a lack of proper maintenance or reinforcement. This requires repair to ensure that the eaves effectively protect the structure from water and rains in the near future. The fresco has deteriorated in color and pattern. The borders of the rectangular panels are disjointed and exhibit substantial voids in the masonry. The degradation has hindered the identification of the original topic of the fresco painting. Furthermore, the absence of coloring has rendered the structure aesthetically unappealing.

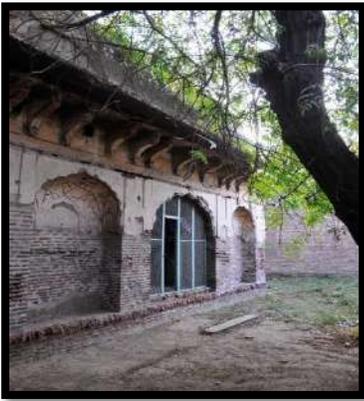
Figure 09 Unmanaged tree and plantation

The tomb was obscured by vegetation. A toppled tree rested against the structure, entangled with electrical lines. The tree branches were fractured and suspended within the tomb via the intentional gaps in the ceiling.

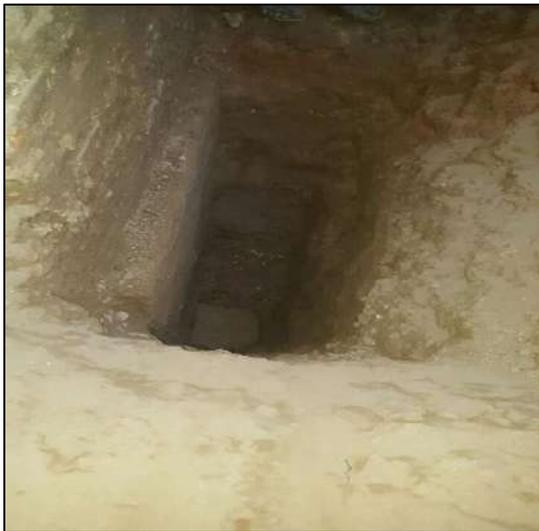
FIGURE 15 OUTSIDE EXCAVATION

Comprehensive excavation was conducted to ascertain the presence of a basement in the building's construction. Furthermore, to ascertain the potential existence of a platform, the inside of the core was excavated, revealing that the Jani Khan Tomb's construction lacked both a basement and a platform. The laborers excavated the site, concluding that the foundation depth is approximately 7 feet 6 inches from the finished floor level.

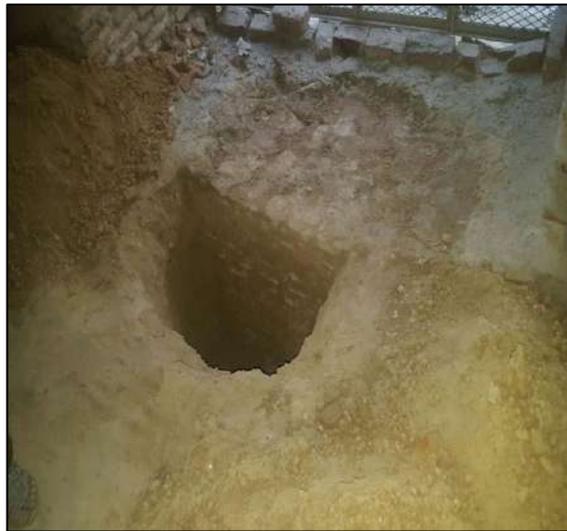
FIGURE 16 INSIDE EXCAVATION

To get a clearer understanding of the floor's foundational material, the inside of the building was dug to a depth of nearly 6 feet; however, no evidence pertaining to the finished floor was discovered. The excavation aimed to determine the original material utilized for the floor construction, but yielded no findings.

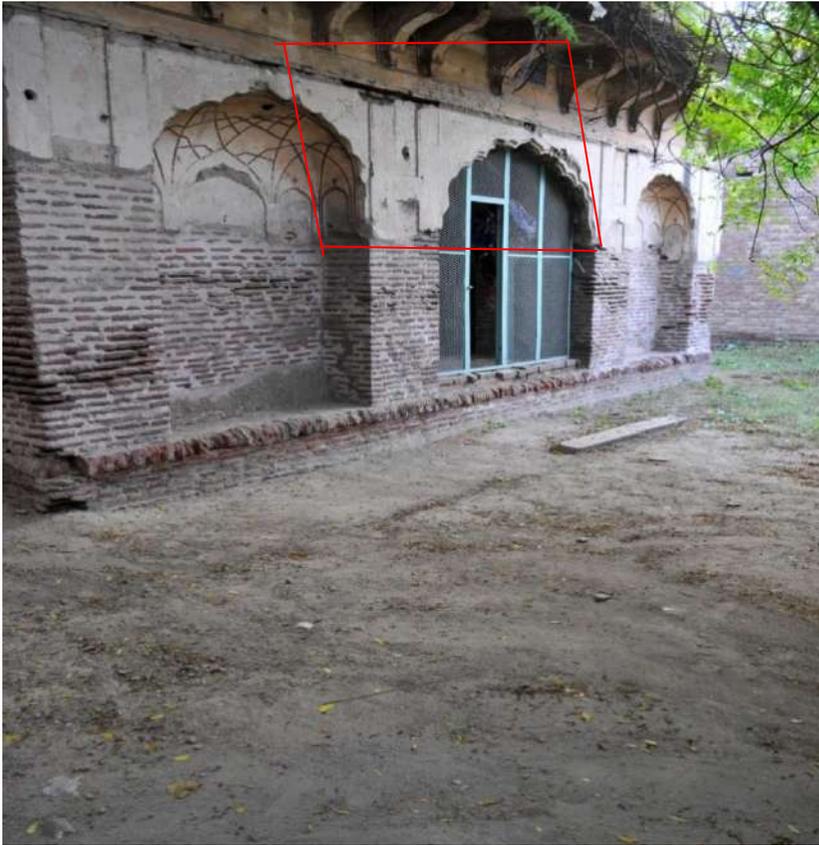
Figure 21 Blind Half Dome Arch

Blind Half Dome Arch: The structure is characterized by its unique form, with one sheer face and three rounded, smooth faces that provide the illusion of a dome bisected. This architectural feature possesses a frontal arch and an

interior depth, lacking any passageway for traversal. This arch possesses the form of a semi-dome from the inside perspective.
